Structural Appraisal of Bradford Interchange Bus Station

B2382824-JAC-S-R-XXX-002

27 February 2024

West Yorkshire Combined Authority

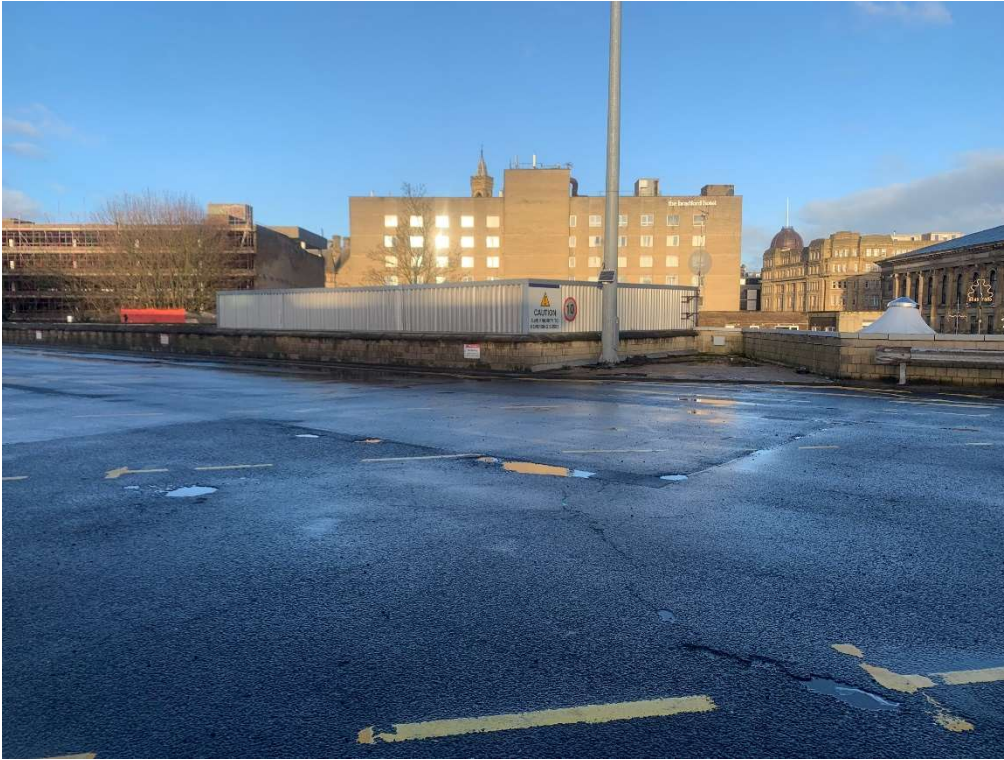
Photo 90- Cracks in tarmac surface
