Structural Appraisal of Bradford Interchange Bus Station

B2382824-JAC-S-R-XXX-002

27 February 2024

West Yorkshire Combined Authority

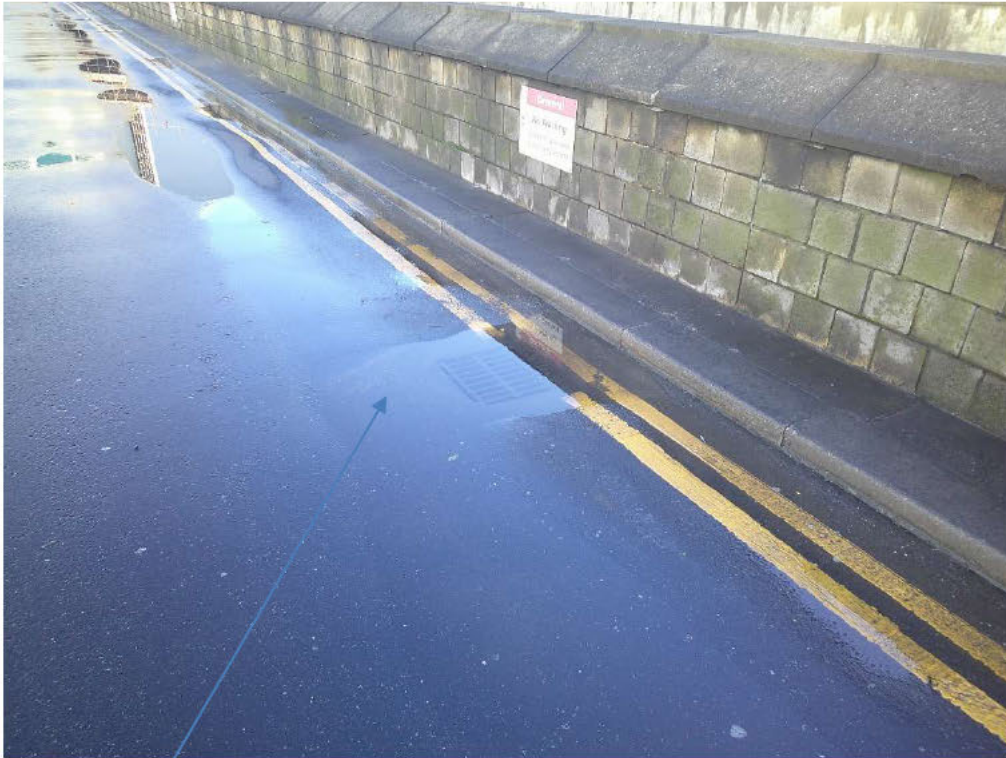
Photo 96 – Blocked gully

- Defective superstructure drainage should be replaced, [REDACTED]
- Routine maintenance to clear superstructure drainage, including gullies around the interchange and pipework beneath the slab.

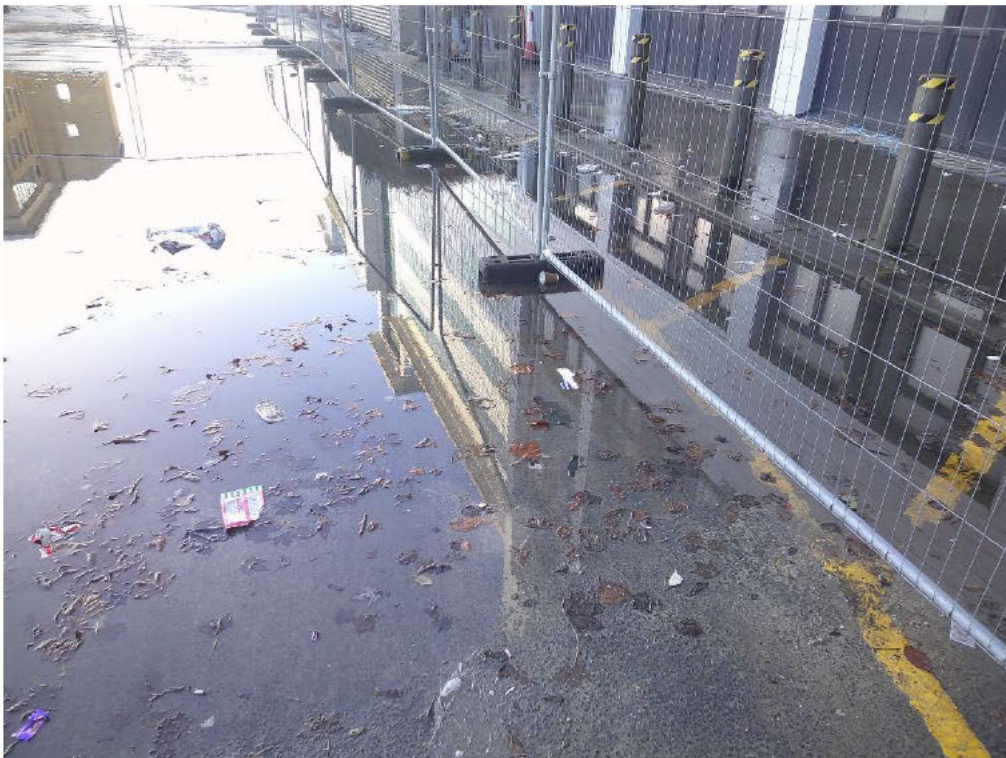
Photo 97 – Water ponding
